AFRL-RX-TY-TR-2011-0048

**FIREFIGHTING AND EMERGENCY RESPONSE
STUDY OF ADVANCED COMPOSITES AIRCRAFT**
Objective 3: Penetrating and Overhauling Wreckage

October 2011

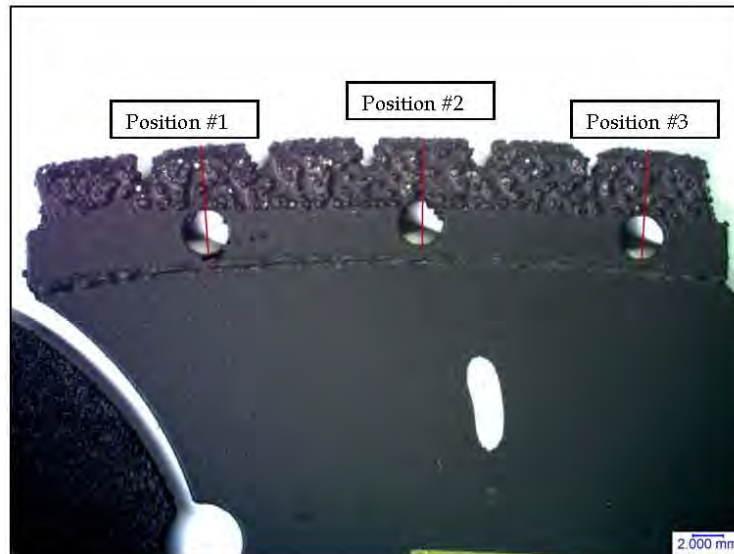
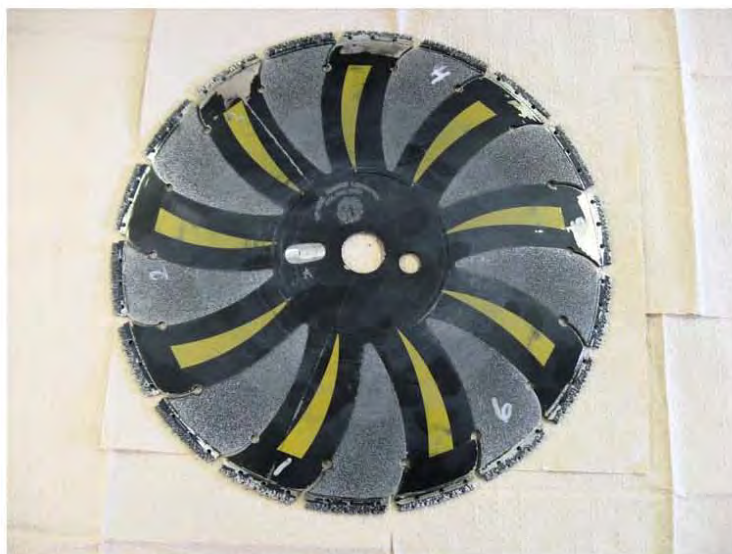
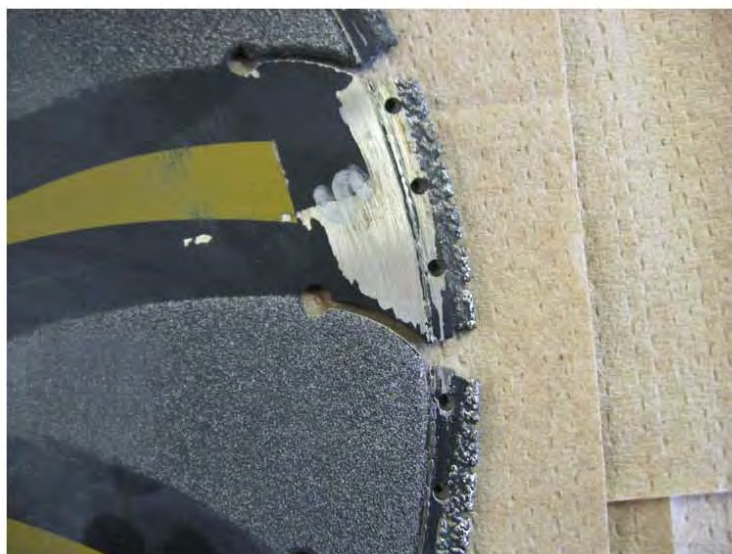
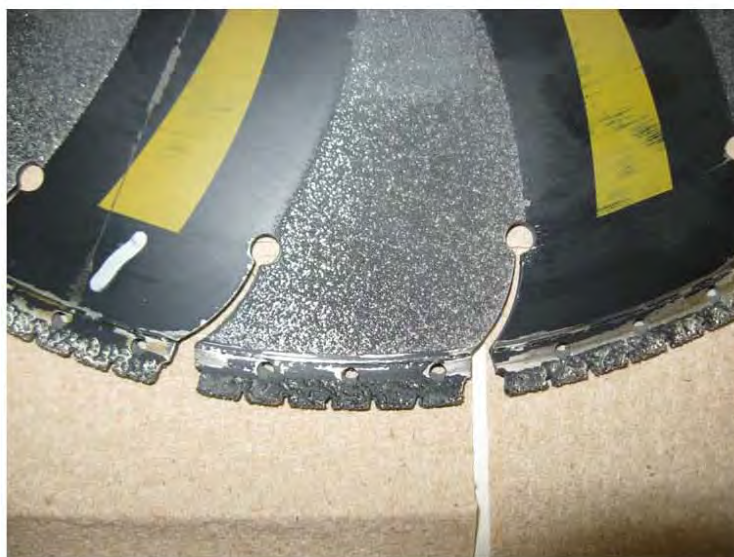
Tooth #	Position #1 (mm)		Position #2 (mm)		Position #3 (mm)	
	Before	After	Before	After	Before	After
1	7.196	7.123	7.063	7.040	7.196	7.125
2	7.067	6.958	7.238	7.040	6.968	6.800
3	7.121	7.041	7.177	6.957	7.120	6.958
4	7.064	6.958	6.897	6.792	7.132	6.970
5	7.231	7.041	7.118	7.042	7.080	6.957
6	7.288	7.124	7.006	6.792	7.070	6.875

Figure 1: Macrograph of Circular Saw NDL 18772 no. 2, before testing, showing position locations

Figure 2: Circular Saw NDL 18772 no. 2, after testing

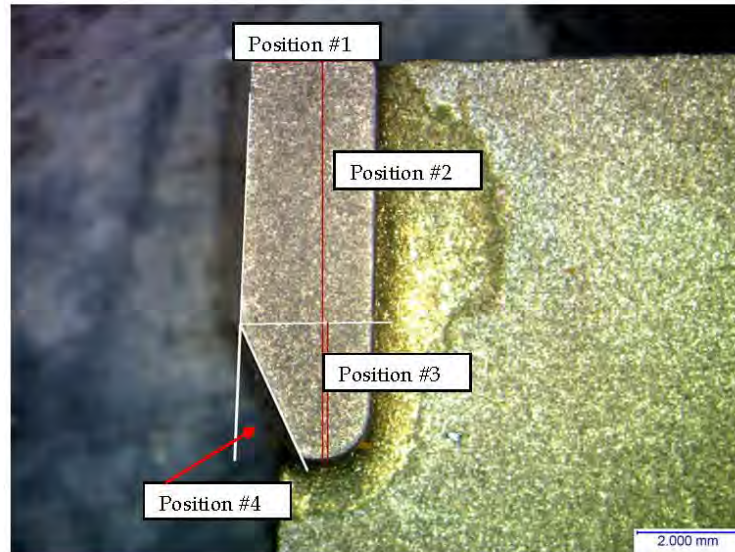
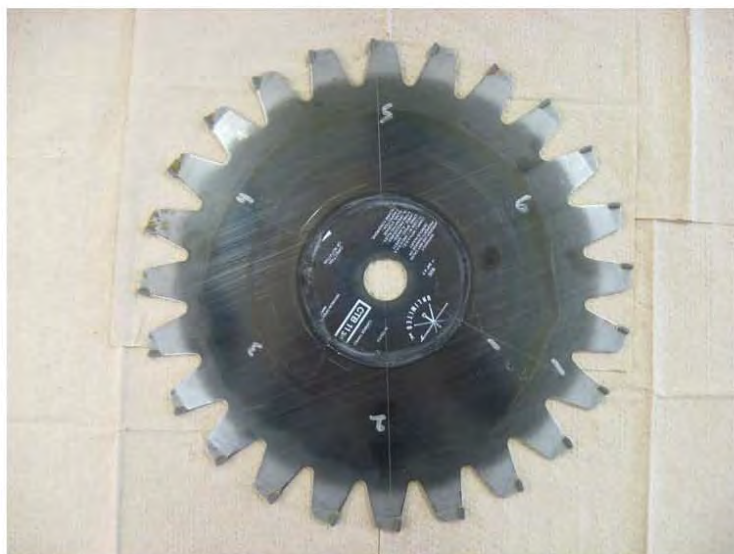
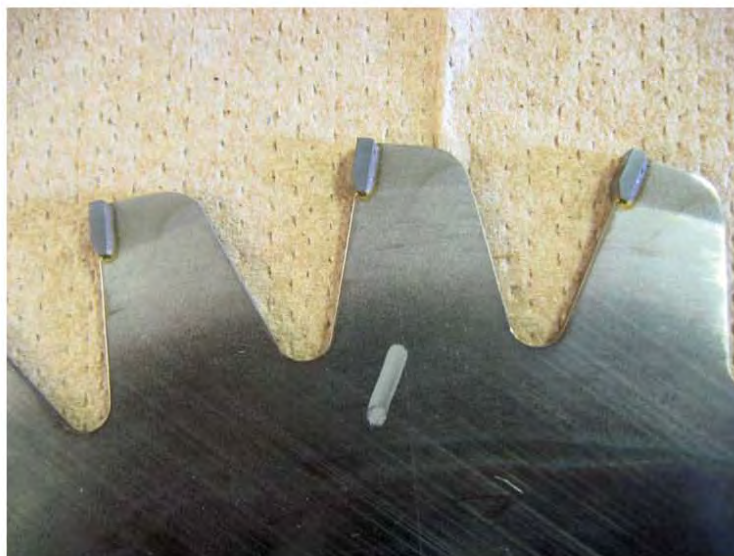
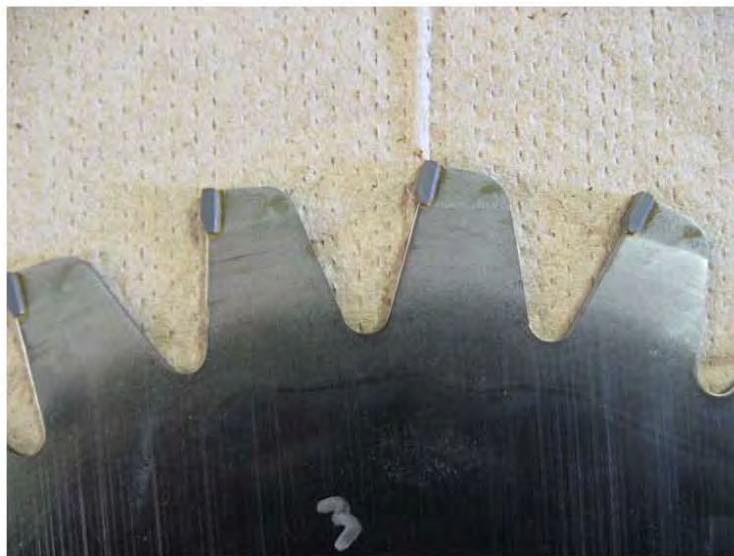
Tooth No.	Position #1 (mm)		Position #2 (mm)		Position #3 (mm)		Position #4 (degree)	
	Before	After	Before	After	Before	After	Before	After
1	2.326	2.205	7.979	7.945	2.513	2.412	23.495	23.354
2	2.409	2.256	8.009	8.006	2.476	2.324	22.650	22.283
3	2.426	2.273	8.042	8.023	2.492	2.375	22.848	22.039
4	2.410	2.222	8.026	7.972	2.476	2.324	24.570	23.694
5	2.394	2.206	8.026	7.991	2.542	2.409	24.921	23.689
6	2.343	2.239	7.959	7.989	2.493	2.307	23.851	22.842

Figure 5: Macrograph of Circular Saw CTB 11 3/4-24 no. 2, before testing, showing position locations

Figure 6: CTB 11 3/4-24 no. 2, after testing

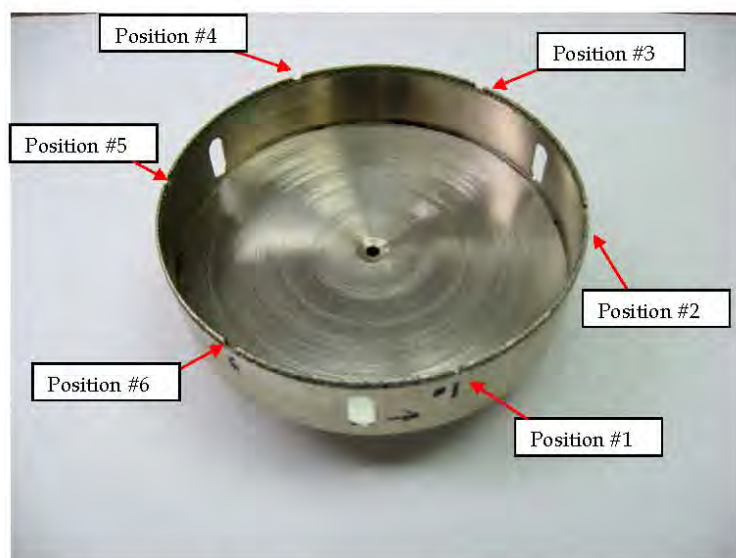
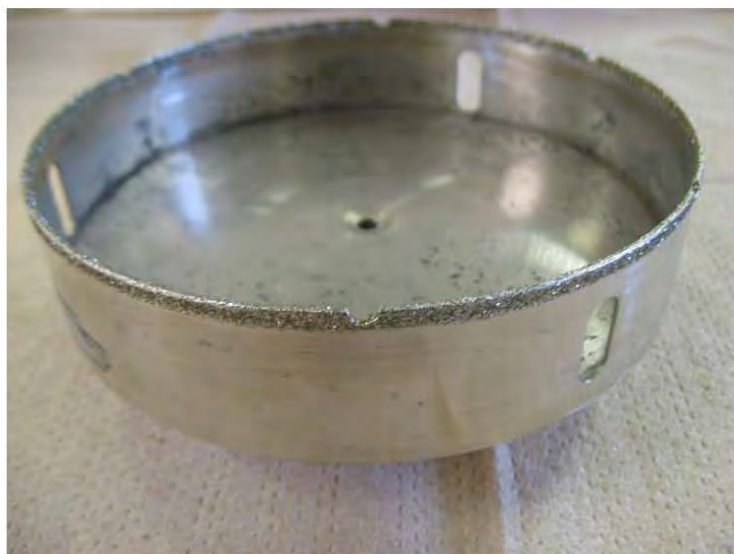
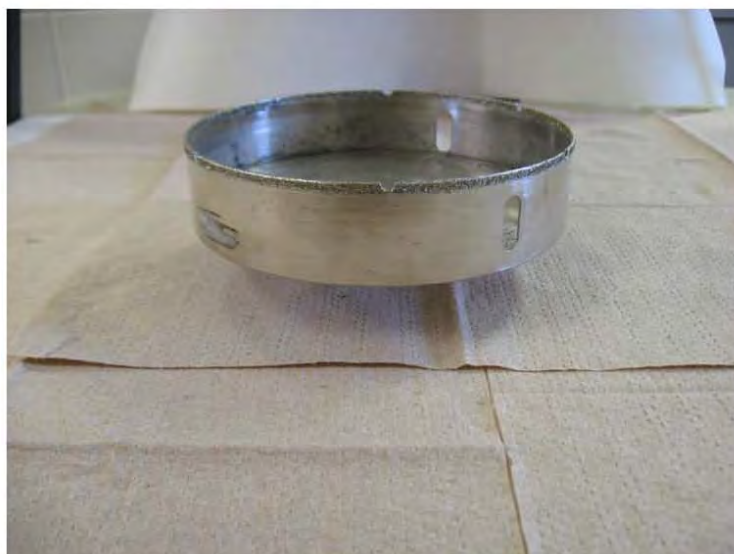
Position #	Before Test (mm)	After Test (mm)
1	35.454	35.426
2	35.592	35.512
3	35.412	35.380
4	35.788	35.584
5	35.460	35.370
6	35.620	35.436

Figure 9: Macrograph of Hole Saw 152 mm before testing, showing position locations

Figure 10: Hole Saw 152 mm after testing

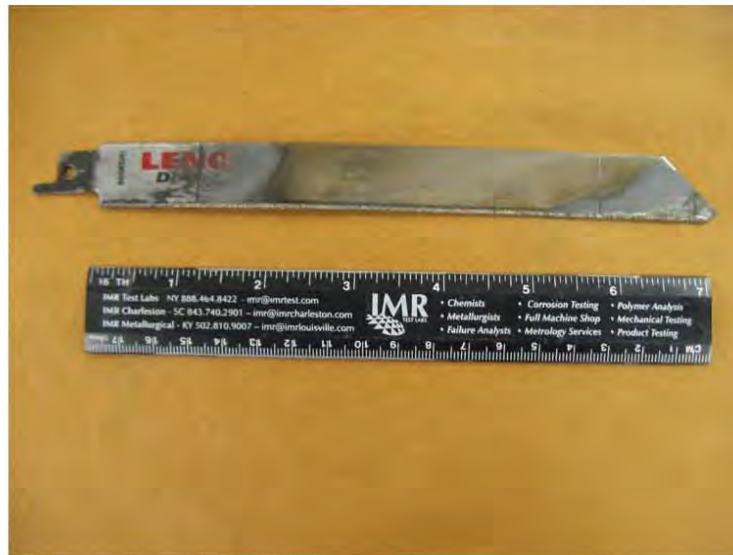
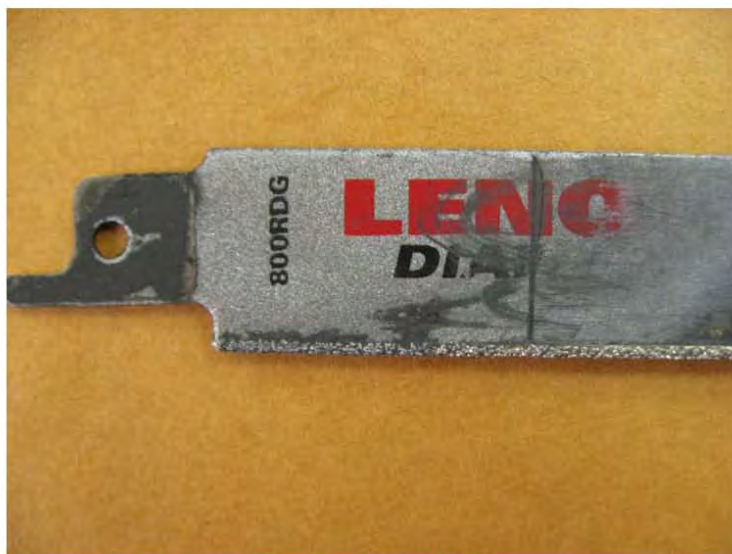
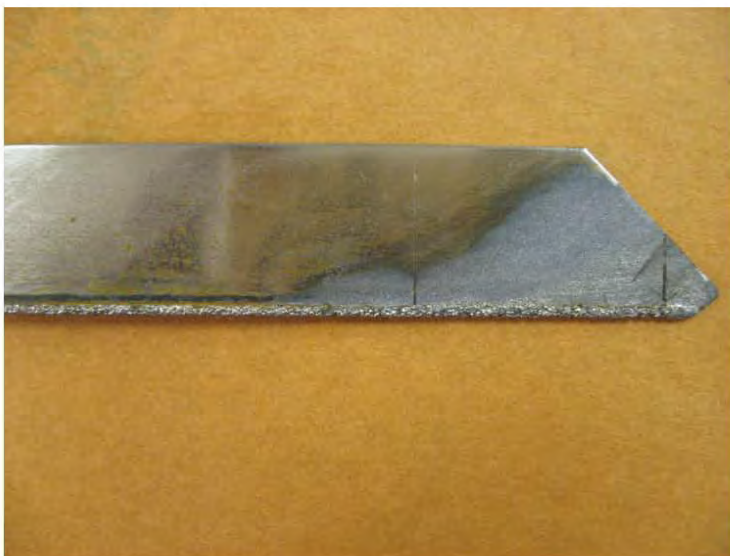
Position #	Results After Test (mm)
1	19.438
2	19.448
3	19.486
4	19.348
5	19.354
6	19.364

Figure 1: Lenox Diamond 800 RDG third round of testing

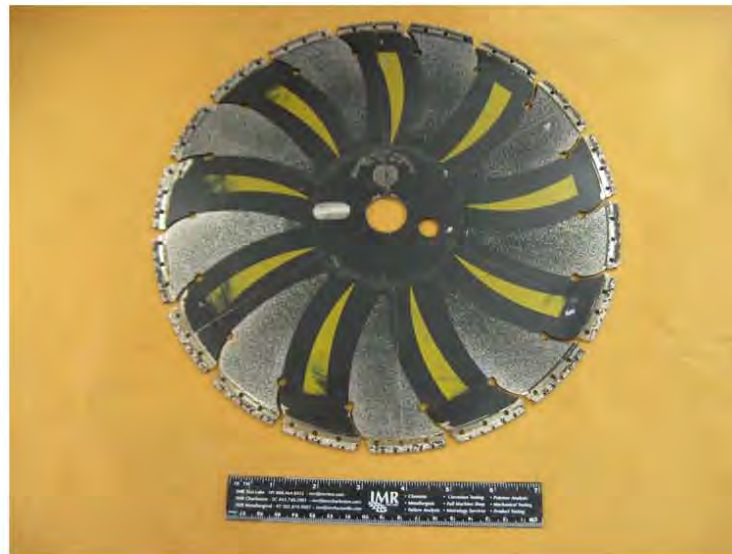
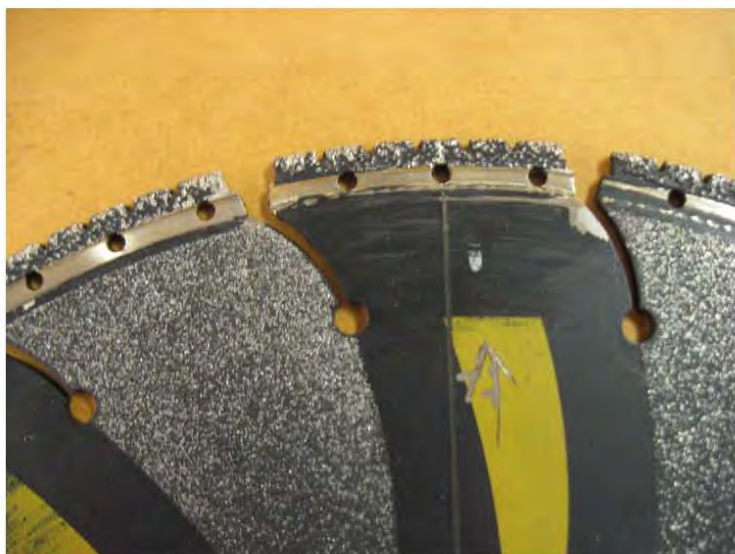
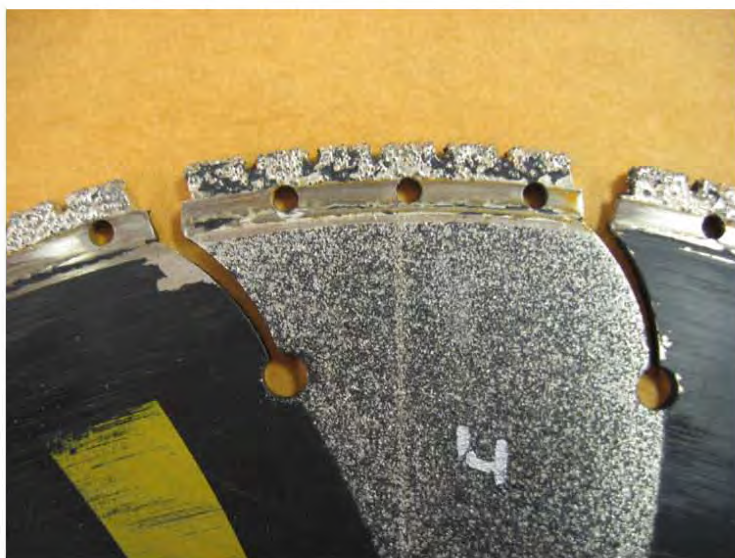
Tooth #	Position # 1 (mm)	Position # 2 (mm)	Position # 3 (mm)
1	6.960	6.994	7.095
2	6.927	6.960	6.788
3	6.994	6.893	6.893
4	6.926	6.825	6.964
5	6.960	7.028	6.927
6	6.859	6.758	6.859

Figure 4: Circular Saw NDL 18772 after third round of testing

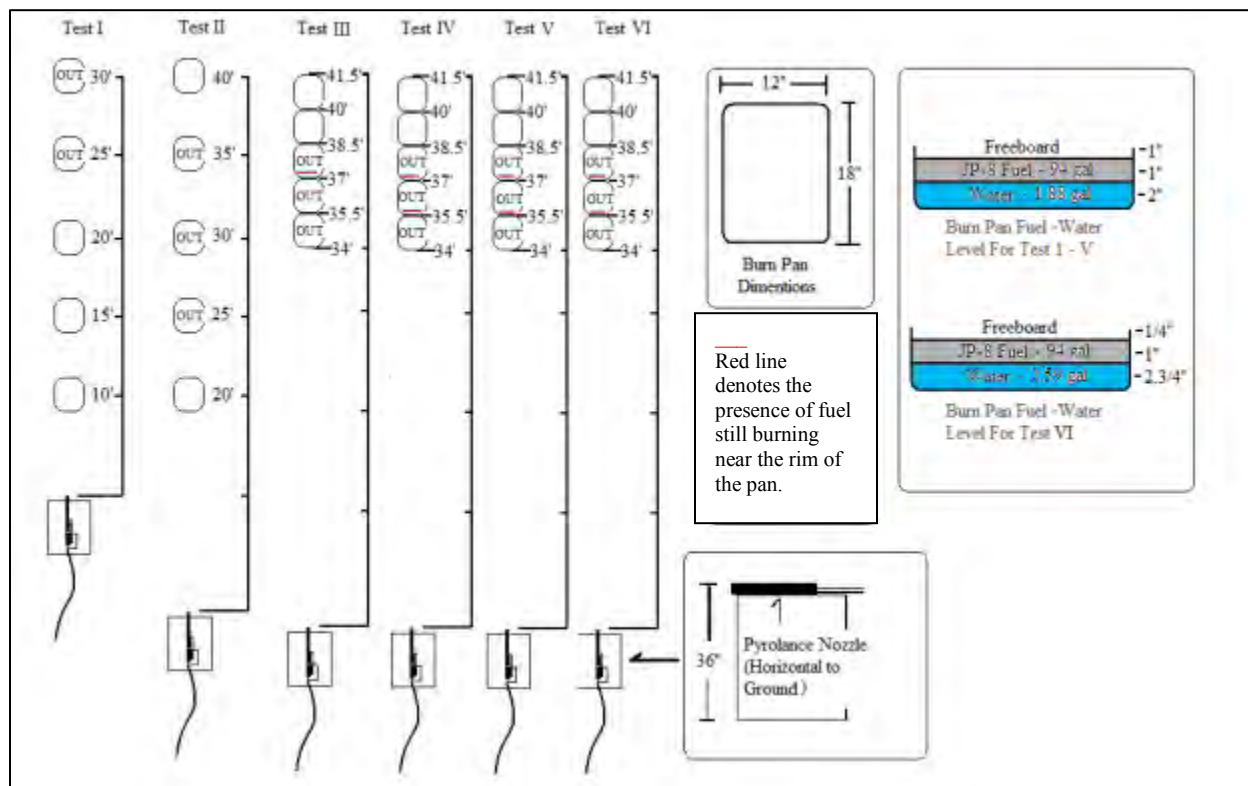
Figure D-1. Schematic of Pyrolance Throw Distance Testing

- Five pans measuring 12-in wide \times 18-in long \times 4-in deep were placed 5 ft apart on center.
- The nozzle was placed horizontally 36 in off the ground and 10 ft from first pan on center.
- The pans were filled with 2 in of water and 1 in of JP-8 allowing 1 in of freeboard.
- A 30 s pre-burn was accomplished after the last pan was ignited.
- The Pyrolance water tank was pre-mixed with 47 gallons of water and 3 gallons of 3% AFFF for a 6% concentration.
- The system was discharged for 60 s and the number of pans extinguished was recorded. Any pans not extinguished during testing were extinguished with a carbon dioxide handheld fire extinguisher.
- Pans 4 and 5 were extinguished during Test 1. Pan 5 was 30 ft 9 in from nozzle tip.

- The results from Test 2 were evaluated and the nozzle was moved back an additional 14 ft and placed. All five pans were spaced together to establish the maximum effective extinguishing distance ± 1 ft.
- The nozzle was placed horizontally 36 in off the ground and 34 ft from front lip of the first pan.
- Pans 1 and 2 were completely extinguished and pan 3 had some fuel near the front rim of the pan still burning. The small amount of area that remained burning in pan 3 was due to the 1 in of freeboard left in the pan reigniting the fuel. The maximum effective extinguishing distance was 37 ft.

- The results from Test 3 were evaluated and three additional tests were conducted to verify the effective extinguishment distance.
- Pan 1 was completely extinguished and pans 2 and 3 had some fuel near the front rim of the pan still burning. The maximum effective extinguishing distance was 35 ft 6 in for all three tests.
